Salisbury Lake Dam (Inventory Number  
VA-04136) James River Basin. Chester  
County, Commonwealth of Virginia.  
Phase I Inspection Report.

4. TITLE (and Subtitle) Phase I Inspection Report National Dam Safety Program		5. TYPE OF REPORT & PERIOD COVERED Final
		6. PERFORMING ORG. REPORT NUMBER

NAME OF DAM: SALISBURY LAKE DAM

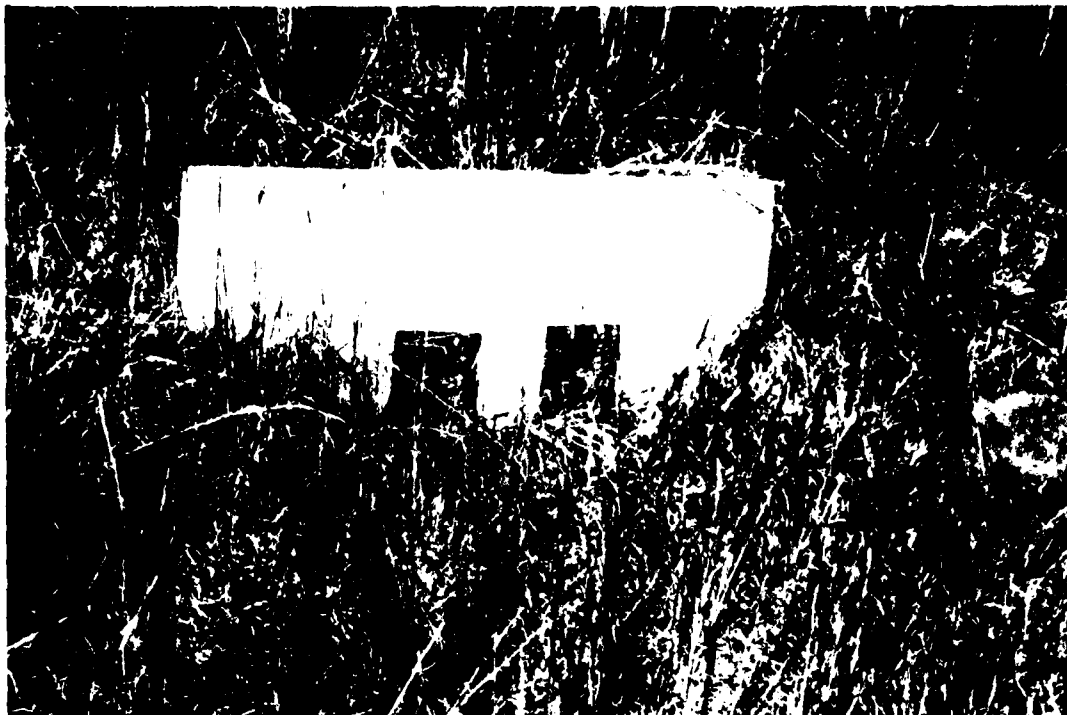
Very slight seepage was observed directly below the outlets of the two 6 inch toe drains (Photo 5). No drainage was occurring directly from the outlets. Animal guards were installed over the outlets. The outlets are situated unusually high on the embankment. Two adjacent seeps, with a combined flow of approximately 3 to 5 gallons per minute (g.p.m.) were observed emerging from the rough concrete adjacent to and discharging into the spillway discharge channel approximately 50 feet upstream of the stilling basin (Photo 8).

**PHOTO 5. Toe Drain Outlets**
